# SEISMIC CONDITION ASSESSMENT OF TEMPLE A CASE STUDY ON SHIVA-PARBATI TEMPLE

Dinesh Raj Bhattra

**Abstract—** Shiva Parvati temple is an uncommon shrine built on a four-step brick platform. It stands out particularly due to its three golden pinnacles. It was Bahadur Shah Idea to construct a hybrid temple that incorporated Newar and Rajput style on top of the pavilion built by King Laxmi Narasimha Malla who ruled in the seventeenth century. The temple has been renovated in 1998AD. The golden pinnacle of this temple is quite artistic and one of the best in the Durbar Square. It consists of three tapering spires alternating with four floral stalks on a small platform. It is unique because it departs from the traditional Newar appearance and adopts the Rajput/Mughal style. Shiva-Parvati Temple which is adorned with images of Shiva and his consort Parvati. With its “Shiva-Parvati Temple” historical importance as Monument underlying the UNESCO World Heritage Sites and One which is affected by the Gorkha Earthquake (2015). The main objective of the study is to carry out seismic condition assessment of the temple based on detail damage assessment. A set of Architectural and Structural D

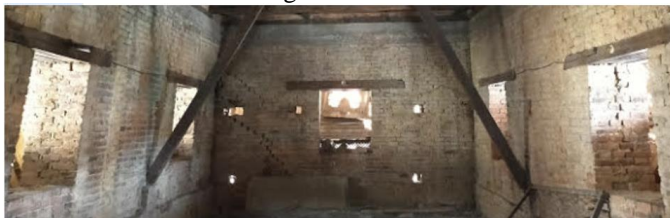
Fig. 9. Cracks observed due to Short Lintel bands

At the opening of each masonry wall, there is a wooden lintel band kept throughout the opening. The bands distribute the stress concentration on the opening to the walls. Due to the short lintel band, a surface crack from the toe of the bands during seismic activity is observed. Major damages were also observed at the west side of the main wall of the first floor due to the inadequate band at the opening. The cracks due to short lintel band are shown in figure 9.

The most efficient way of Conservation is by providing adequate number of Chukul / Spikes / Wedges to connect the Joist and Wall which increases the lateral strength of wall, Continuous Bands throughout the periphery, Corner Stiches at the Wall Junctions & Wooden Posts and Beams in the form of frame from the inside.
