# A REVIEW ON PERFORMANCE OF EARTHFILL DAMS DURING PAST EARTHQUAKES

Roshan Singh Chouhan  
Civil Engineering Department  
IPS Academy  
Institute of Engineering & Science,  
Indore, M.P. India

Swatilekha Guha  
Civil Engineering Department  
IPS Academy  
Institute of Engineering & Science,  
Indore, M.P. India

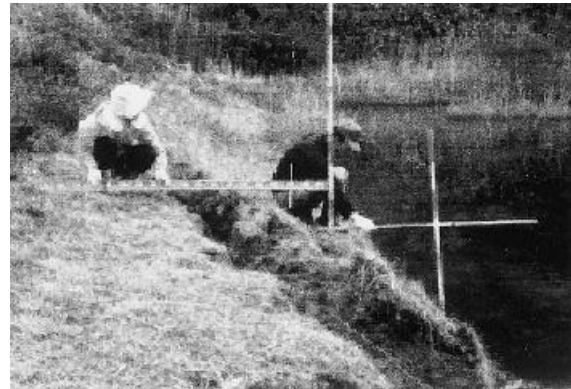
**Nihonkai-Chubu earthquake** (also known as 1983 Sea of Japan earthquake) occurred on May 26, 1983 at 11:59:57 local time (02:59:57 UTC). It had a magnitude of 7.8 on the moment magnitude scale. It occurred in the Sea of Japan, about 100 km west of the coast of Noshiro in Akita Prefecture, Japan. The earthquake lasted approximately for about 60 seconds. Most of the damage was due to soil liquefaction which causing the collapse of houses and a number of road and dams. The degree of liquefaction was the worst seen in Japan since the Niigata earthquake. The greatest effects were observed in areas underlain by loose Holocene Aeolian and fluvial sands due to this earthquake about 145 dams failed and damaged in Japan. Hinks(2015) observed the failure was:

- Sliding of slope
- Longitudinal crack more than 50 mm wide
- Transverse crack
- Crest settlement more than 300 mm
- Leakage of water

Fig.1 The damage to the Yamanaka dam caused by the 1983 Nihon-kai Chubu earthquake

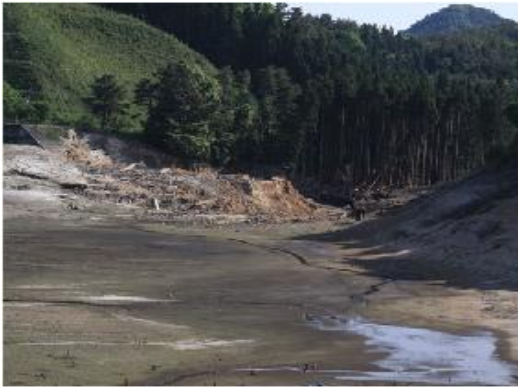
water reservoir that in used for irrigation purpose [JCOLD, 2011]. The embankment dam started to fail after the earthquake occurred and completely destroyed during 20 minutes. Before the earthquake occurrence, the dam reservoir was full. The bank of 18 m height and 133m length failed just after earthquake occurrence. The dam was not designed under consideration of seismic forces.

Fig.2 Dam failure at Fujinuma

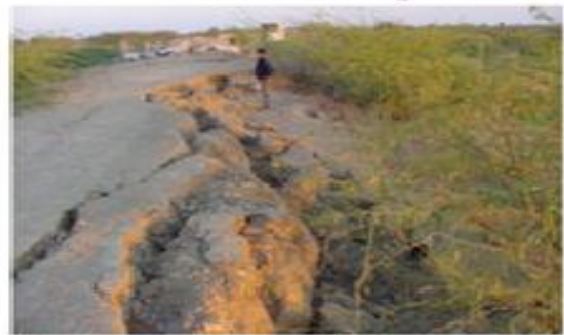
Another dam Fatehgadh Dam, constructed in 1979, is an earth dam with a maximum height of 11.6 m and crest length of 4050 m and the Fatehgadh Reservoir was nearly empty during Bhuj Earthquake. However, the alluvium soils underneath the upstream portion of the dam was saturated at that time. Bhuj Earthquake triggered failure near the bottom portion of upstream slope (EERI 2001) possibly because of localized liquefaction near the upstream toe of the dam. The EERI (2001) also found cracks as deep as 1.5 to 1.7 m within the upstream portion of the dam and instability near the top portion of the downstream slope following the earthquake. The problem of appearance of longitudinal cracks may indirectly relate to liquefaction of foundation soils.

Embankment Failure - Bhuj Earthquake, 2001

Fig.3 Dam failure at Bhuj 2001
