DAMAGE ASSESSMENT OF RCC STRUCTURE USING NON - DESTRUCTIVE TESTS

The building under consideration is a G+9, multistorey residential building developed by Ghaziabad development authority(GDA). It is located in Vaishali, Ghaziabad, U.P., India. Damages in this building includes reinforcement corrosion, cracks in concrete, spalling. It also hosts leaking pipes, de-laminations in columns, beams corners located at different heights, beam soffits, slab soffits, leached plaster on parapets corroded and leaking drainage pipes, RCC masonry wall interfaces cracks in masonry in-fills even complete crumbling at some places, heavy de-bonding and dismantling of plaster at both exterior and interior surfaces etc. These were further damaged by the rain and environmental conditions. Due to fast deterioration, it was decided to assess the damage and find its health condition and future life span of the buildings at the earliest.

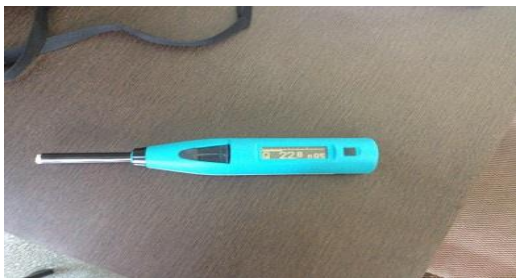
Figure 1: Rebound Hammer

A simple electronic equipment called Rebound Hammer or Schmidt Hammer is used for this purpose. The schematic diagram of operation of rebound hammer is given

As per IS 13311-2; when the plunger of rebound hammer is pressed against the surface of the concrete, the spring controlled mass rebounds and the extent of such rebound depends upon the surface hardness of the concrete. The surface hardness and therefore the rebound is taken to be related to the compressive strength of the concrete. The rebound is sent along a graduated scale and is designated as the rebound number or rebound index.

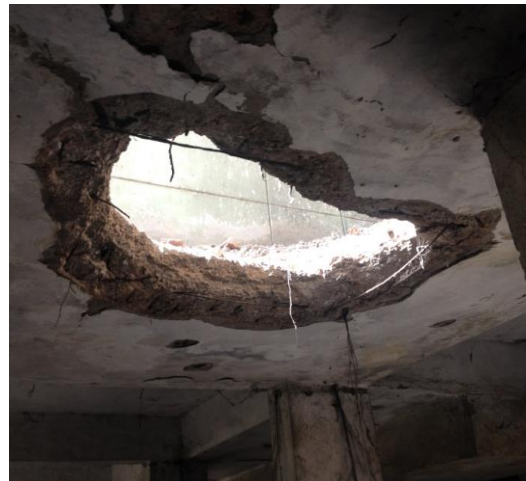
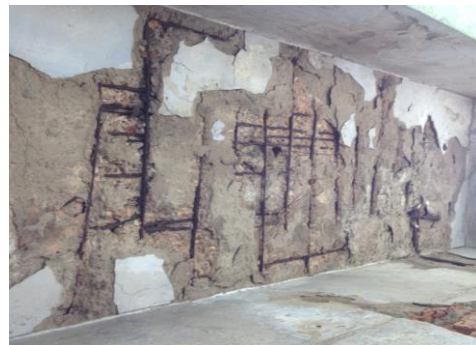
1. Visual inspection of the building indicated heavy corrosion due to environmental attacks.
2. At certain locations of beams, columns, and slabs concrete cover had got spalled and some shear stirrups on the outside face of columns in basement were totally eaten up by corrosion.

3. Cracking and spalling, cracking and rust staining or rust on reinforcement in 1-4 floors of the building is visible and this is mainly because of corrosion of steel in concrete.

4. At most columns in the ground floor and first floor cracks were seen running along the reinforcement location and cracking along the bar is an important indication that the reinforcement is subjected to corrosion.

5. At right angles to main reinforcement cracks were seen, these cracks are generally because of structural deficiency.
6. Beam - column junctions were badly cracked indicating irregularities in load on columns because of design failure.

7. At the first floor a big hole in slab was found and reinforcement of that portion is hanging. This has happened because the partition walls of the above floors had broken down and fallen in that part of the slab.

8. Every partition walls in between each floor are seen broken and completely fallen into pieces. A number of columns had continuous vertical cracks along the line of concrete cover thickness.
9. The sideways of staircases of ground floor and first 4 floors are completely damaged and the first step in the staircase leading to second floor is completely missing/damaged. Reinforcement of this step is seen hanging.
10. At terrace floors of the building, spalling of concrete is seen. On inspection it was found that rainwater disposal system was not properly provided, hence stagnation occurred and its effect visible to naked eye.
11. At some locations architectural and design failure is seen.

Based on the visual survey, non-destructive test results, conducted on the building the following conclusions can be made. The cause of cracks/damage were found because of varying loads, poor grade of concrete. The reinforcement in columns was not adequate and of good quality. The cracks/damage to the structure has left it unsafe. A bit of substandard quality of concrete and poor quality of shuttering used. The quality of construction used was not as per standards and process of construction was not supervised by qualified engineers. The values of pulse velocity and rebound hammer of non-destructive tests have shown large variations which indicate the inconsistency in the concrete used for the construction. There is no substitute for good quality of concrete construction practices. The quality control of materials and workmanship must be strictly checked at the site. Poor practices of construction cannot be rectified at later stage except repeated costly retrofitting to keep structure functional. The structural design needs to be revised for a high rise building like the one under study. The damaged components have to be re-designed/repared/retrofitted/re-casted depending upon the degree of damage.
