DETECTION AND LOCATING LEAKS IN UNDERGROUND WATER MAINS USING THERMOGRAPHY

Dr.E.N.Ganesh
Professor, Department of ECE
Saveetha Engineering College, Chennai

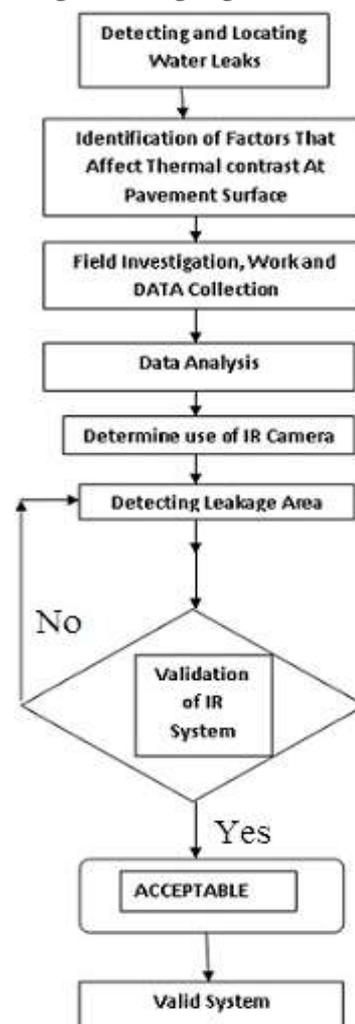
Figure 1: Proposed Methodology

The methodology presented in this study is based on intensive literature review, meeting with experts, and on the analysis of actual data collected from web site. The development of the methodology involves five major steps: I) identification of factors that affect thermal contrast at pavement surface; II) field investigation and on site experimental work; III) analysis of the data obtained in order to determine the most suitable conditions of using IR camera for the detecting and locating water leaks, IV) establish the relationship between the detected leakage area at pavement surface and the location of leak in the water main being tested; V) validation of the proposed methodology by comparing leak locations detected by the proposed system and by acoustic-based methods. Figure 1 shows the proposed methodology.

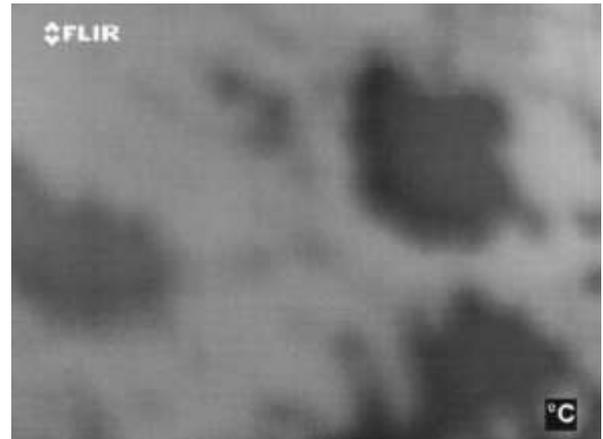
Figure 2: Thermal Contrast at Pavement Surface due to Water Leak

Figures 3 shows the relationship found between pipe temperature, average ambient air temperature and average pavement temperature in fall season. As shown in Figures 2 the warmer pipe temperature indicates high possibility in detecting water leaks using IR camera according to Equation 1 (ASHRAE 1981; Hutcheon and Handegord 1983; Bentz 2000)

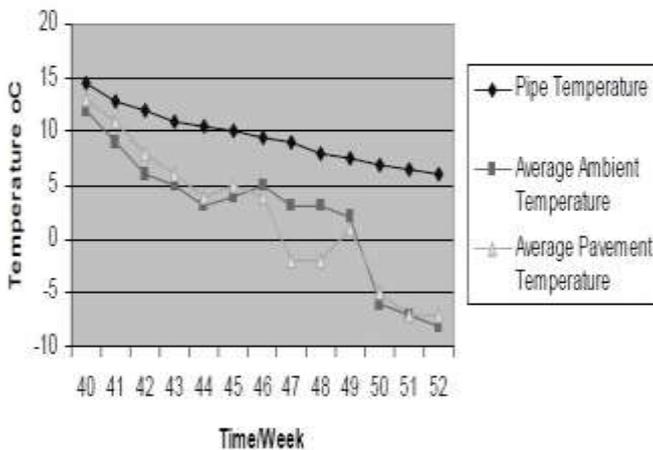
. Figure 3: Comparison between Temperatures in a Season

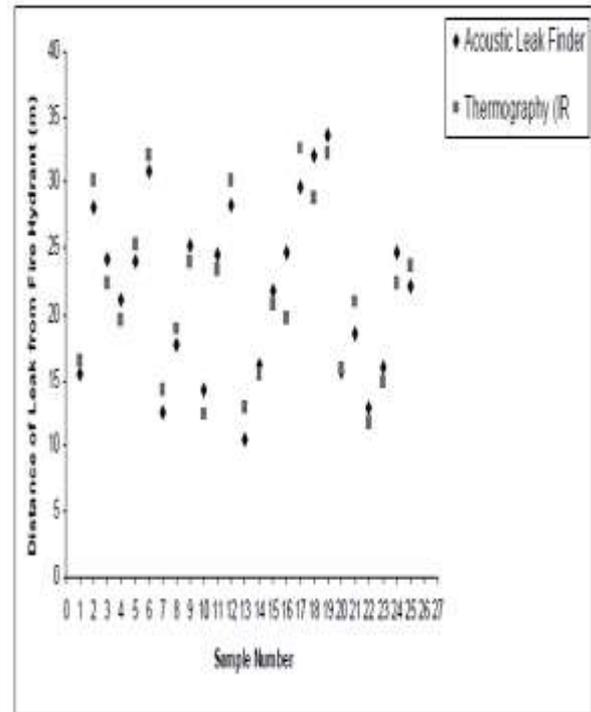
The leak locations detected using IR camera for twenty five water leaks were compared to those detected using the acoustic-based leak finder method. The results are shown in Figure 4. As shown in Figure 4 the difference ranged from 1.01m to 2.30m

Figure 4: Leak Locations (m) using Acoustic Leak Finder Verses IR camera

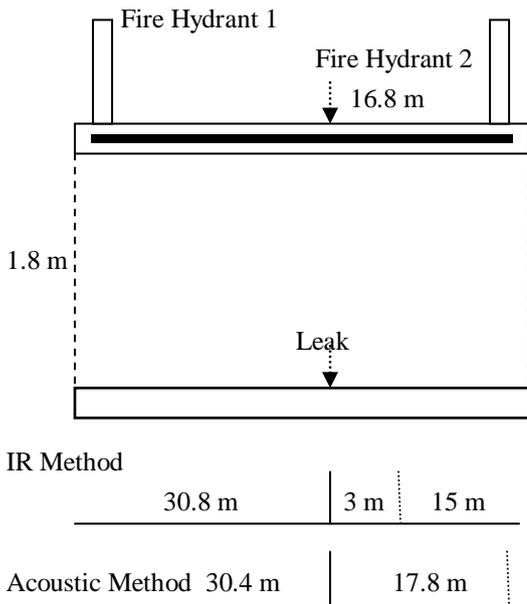
The results obtained is shown in Figure 5

- 1- image number 6 showed thermal change as shown in Figure 5
- 2- The user moved to the location represents image number 6 and perform further investigation.

$$X = \frac{(N-1)0.28S}{R} = \frac{(6-1) \times 0.28 \times 6}{0.5} = 16.8 \text{meter} \quad (3)$$
