# GEOLOGICAL ASSESSMENT OF DAM CONSTRUCTION MATERIALS: A FIELD INVESTIGATION FOR THE NAM-A HYDROPOWER PROJECT, LAO PDR

Phanthoudeth Pongpanya, Banthasith Vongphuthone, Vongsavanh Soysouvanh  
Department of Mining Engineering,  
Faculty of Engineering  
National University of Laos,  
Vientiane, Lao PDR

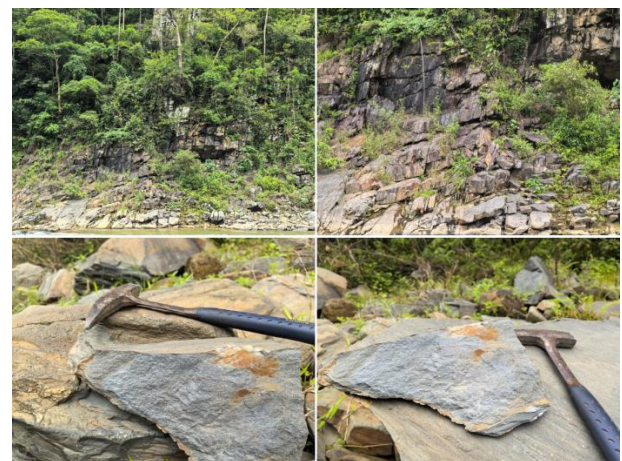
Quartzitic sandstone is the rock unit mostly found in the middle of the study area. It was formed during the middle to upper Ordovician period. The quartzitic sandstone found in the project area is a sedimentary rock composed primarily of quartz grains. These grains are tightly cemented together, often by silica or iron oxide, giving it a very hard and durable nature. Its distinctive appearance, often with a gritty texture and a pale color ranging from white to grey, is due to the high concentration of quartz. Additionally, the quartzitic sandstone is a hard, massive, slightly weathered, and medium grained rock which required significant number of blows of the geological hammer to fracture it.

Quartzitic sandstone layers are generally orientated in the NW-SE direction and gently dipping in the NE direction. The dip angle of quartzitic sandstone measured from the exposed outcrops ranges from 75 to 80 degrees. Fig. 3 shows typical outcrops and textures of the quartzitic sandstone.

Fig. 3. Typical outcrops and textures of quartzitic sandstone found in the project area

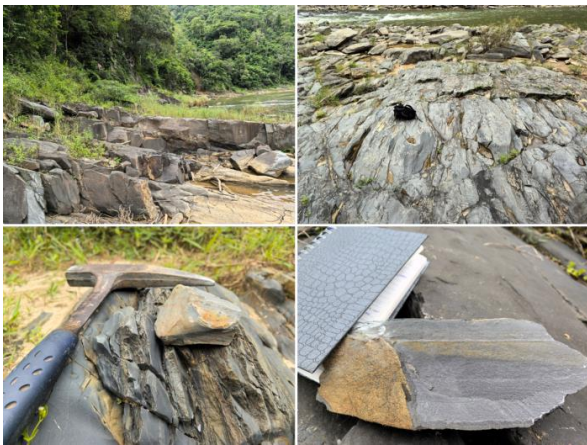
Clay shale was formed during the middle to upper Ordovician period. This rock unit were observed mostly in the northeast part of the project area. The observed clay shale is a fine-grained sedimentary rock composed primarily of clay minerals. It has a layered or foliated appearance due to the alignment of the clay particles. The clay shale is slightly weathered and generally hard, which required more than one blow of the geological hammer to break it. The color of clay shale can vary widely depending on the presence of other minerals. However, this rock unit found in the project area is largely dark grey in color. Fig. 4 shows typical outcrops and textures of the clay shale. The clay shale layers are generally orientated in the NW-SE direction and gently dipping in the NE direction. The dip angle of this rock unit measured from the exposed outcrops ranges from 70 to 75 degrees.

Fig. 4. Typical outcrops and textures of clay shale presented in the project area

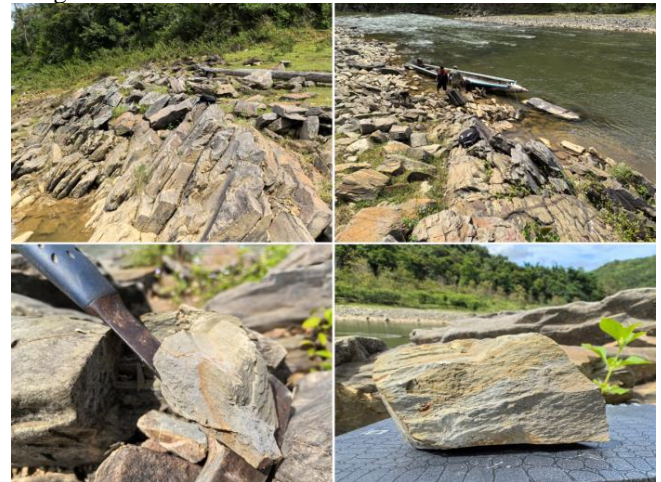
Tuffaceous siltstone is the rock unit which was formed during the period of lower to middle Ordovician. This rock unit was mostly found in the southwest of the proposed dam area. The tuffaceous siltstone observed in the project area is a sedimentary rock composed primarily of silt-sized particles with a significant amount of volcanic ash, known as tuff. The tuff is derived from volcanic eruptions and is incorporated into the sediment during deposition. The tuffaceous siltstone is a soft, light grey, and slightly to moderately weathered rock, which required only a single blow of the geological hammer to fracture it. Fig. 5 shows the tuffaceous siltstone outcrops and its textures found along the Nam-A riverbanks. The rock layers are generally orientated in the NW-SE direction and gently dipping in the NE direction. The dip angle of tuffaceous siltstone measured from the exposed outcrops ranges from 50 to 55 degrees.

Fig. 5. Tuffaceous siltstone outcrops and its textures found along the Nam-A riverbanks

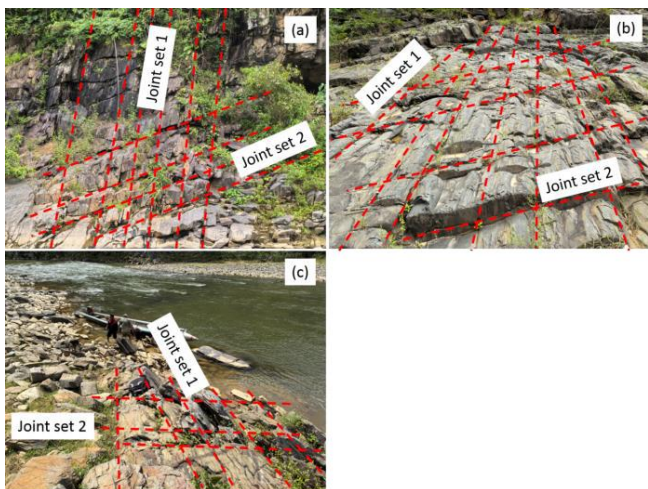
Fig. 6.a demonstrates the orientations of joints on the quartzitic sandstone body. Joint set 1 is orientated in the NW SE direction and steeply dipping in the NE direction by approx. 77 degrees. In contrast to joint set 1, joint set 2 is orientated in the NE-SW direction and dipping in the NW direction by approx. 18 degrees. Fig. 6.b illustrates joint set orientations that occurred on the rock body of clay shale. Joint set 1 is orientated in the NW-SE direction and steeply dipping in the SW direction by approx. 73 degrees. Whilst, joint set 2 is orientated in the NE-SW direction and steeply dipping in the SE direction by approx. 82 degrees. Fig. 6.c demonstrates the orientations of joints on the tuffaceous siltstone body. Joint set 1 is orientated in the NW-SE direction and steeply dipping in the NE direction by approx. 53 degrees. In contrast, joint set 2 is orientated in the NE-SW direction and steeply dipping in the SE direction by approx. 85 degrees.

Fig. 6. Orientations of joint sets observed within the project area. (a) orientations of joint sets found on quartzitic sandstone. (b) orientations of joint sets presented on clay shale. (c) orientations of joint sets observed on tuffaceous siltstone

In the project area, major geological structures such as fault and fold were not observed during the fieldwork. Geological structures found within an area include bedding planes and rock joints. Bedding plane orientations of the rocks are mentioned above. In general, two joint sets were observed on quartzitic sandstone, clay shale, and tuffaceous siltstone. The joints are moderately to widely spaced and opened with no infilling materials between rock joint surfaces. The space of joints is generally between 0.5 m and 1 m, it is however locally less than 0.5 m in some areas.

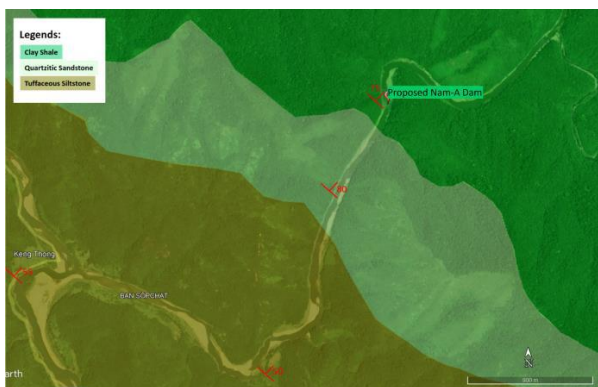
The geological map of the project area is illustrated in Fig. 7. The geological map provides the information of bedrock distribution within the study area and it is important in assessing the type and location of potential crushed aggregate sources.

Fig. 7. Geological map of the project area

The geological map given in Fig. 7 shows the distribution of potential crushed aggregate sources which is essential for resource assessments. The geological map of the project area serves as a primary source of information for determining the location of potential sources of crushed aggregate. The distribution of bedrock units suitable for crushed aggregates, such as quartzitic sandstone and clay shale presented on the map is sufficient for identifying the general areas where the target rock type is at or near the surface.

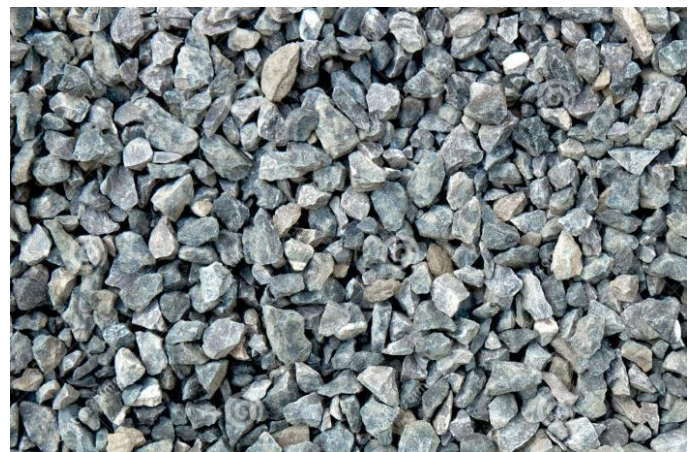
large cobblestones. Generally, rock is crushed to produce construction aggregates for using in cement concrete. Crushed aggregate is normally produced from three main groups of rocks such as sedimentary, igneous, and metamorphic rocks. Sedimentary rocks of limestone and dolomite, composed of carbonates, generally make good sources of crushed aggregate. With the absence of these carbonate rocks, clastic sedimentary rocks of conglomerate, breccia, and sandstone are used for crushing. Of these rocks, when sandstone is hard and dense, it is most commonly used for crushed aggregate and is a major source of crushed aggregate in some areas. Igneous rocks of granite, diorite, andesite and metamorphic rocks of marble and quartzite, are commonly hard, tough and dense and make an excellent source of crushed aggregate, however, these rocks are not present in the project area. Fig. 8 illustrates the example of crushed aggregate produced from sandstone.

Fig. 8. Example of crushed aggregate produced from sandstone

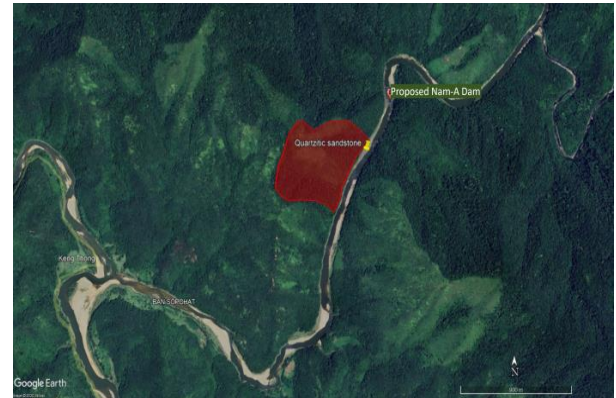
Fig. 9 shows the areas where potential crushed aggregates of quartzitic sandstone are at. The potential source of quartzitic sandstone crushed aggregates is located in the downstream area of the proposed dam, as it is marked in red polygons, approx. 650 m downstream of the proposed dam location. From the economic point of view, the location of potential crushed aggregate quarries must be selected as close as to the construction site of the proposed dam, if available.

Fig. 9. Area of potential crushed aggregates of quartzitic sandstone

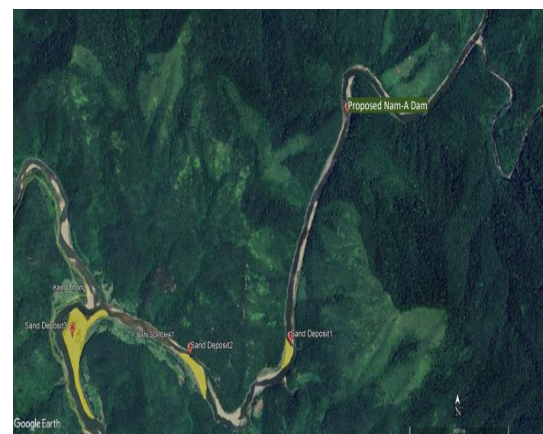
Sand deposit is an accumulation of durable rock fragments and mineral particles. Such deposit results from the disintegration of bedrock and subsequent transport, abrasion, and deposition of weathered fragments. Water is the principal geological agent that affects the distribution of the sand deposit. In the project area, most sand is found along the riverbed of Nam-A River which are called river terrace deposits. Locations of sand deposits found within the area during field investigations are shown in yellow polygons (Fig. 10). The distance of Sand Deposits 1, 2, 3 from the proposed dam site is approx. 1.75 km, 3.15 km, and 4.55 km, respectively.

Fig. 10. Location map of sand deposits found in the project area

The sands deposited at these three locations are medium to coarse-grained and well-sorted, which are possibly suitable for using as fine aggregate in cement concrete for dam construction. Therefore, their properties and extents need to be confirmed. The outcrop and grain size of the sand deposits can be seen in Fig. 11. Sand Deposits 1 and 2 have smaller extents when compared with Sand Deposit 3. The areal extent of Sand Deposits 1, 2, and 3 is approx. 10,000 m<sup>2</sup>, 23,000 m<sup>2</sup>, and 90,000 m<sup>2</sup>, respectively.

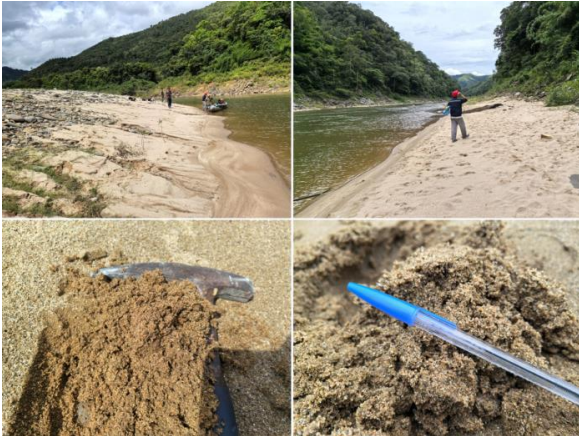
Fig. 11. Sand deposits found in downstream areas of a proposed dam site along the Nam-A River
