# FEASIBILITY ASSESSMENT FOR DRILLING AND REHABILITATION OF WATER SUPPLY BOREHOLE SCHEME AT AWARO CAMPUS, AMBO UNIVERSITY

Mr. Tibebu Tsegaye Zigale  
Assistant Professor,  
Department of Hydraulic and Water Resource  
Engineering  
Ambo University, Ambo, Ethiopia

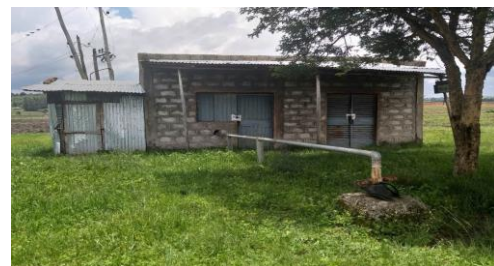
Fig. 2: Awaro Campus Water Borehole

This study was conducted at the Institute of Technology (IOT), Ambo University, Ethiopia. Ambo is located in the West Shewa zone of the Oromia region, 125 km west of Addis Ababa, this town has a latitude of 8°59'N ,longitude of 37°51'E and an elevation of 2101 meters as shown in figure 1. The institute of technology campus of the Ambo University which is dedicated to engineering departments, housing more than 7000 students. The existing borehole as shown in figure 2 was working with its full capacity up to 2015. But the borehole was functioning and supplying water to meet the requirements of institute from 2014. After it has

been working with the yield of 25-26litre/sec at the time of construction was reduced to 14-15 litre/sec. Because of this, maintenance and borehole washing has been done, so by doing this restarted to function the institute up to the end of 2015 but without much working, because of getting reduced yield capacity of the borehole decided to stop function.
