EVALUATION OF FAILURE PATTERN ON A FLEXIBLE PAVEMENT A CASE STUDY OF WARAWA LOCAL GOVERNMENT KANO STATE

A.B. Shehu¹, A. Zaid, A.B Abdulkarim, F.L Zubair, S.H. Jido

Nigeria Building and Road Research Institution (NBRI), Northwest Zonal Office, Kano

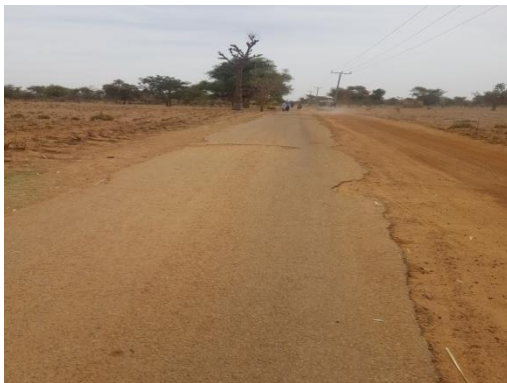
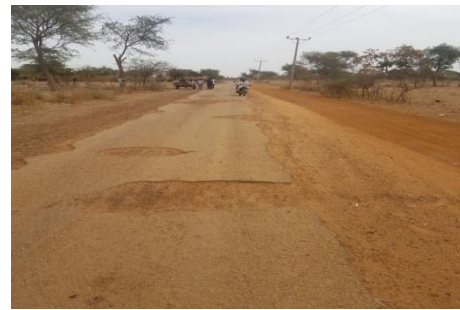
Fig. 3.2: Raveling (from visual site survey)

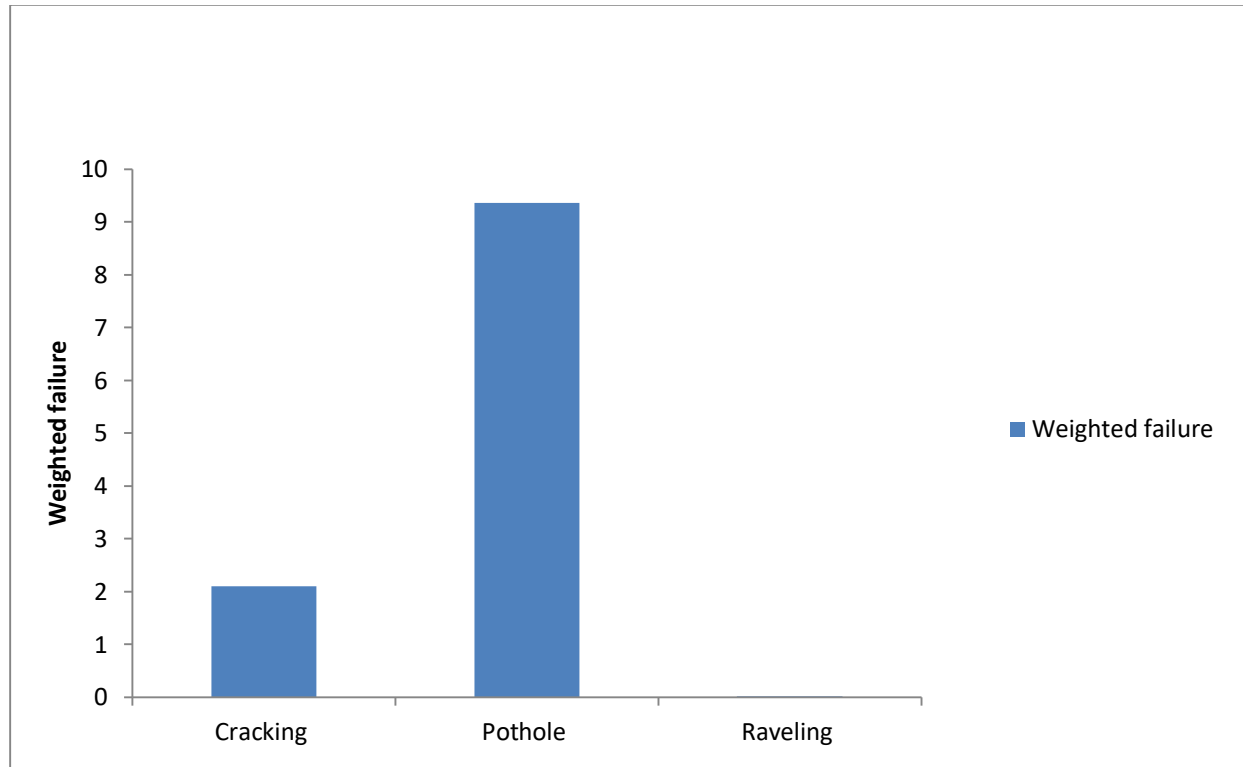
Figure 3.0: Weighted failure versus Distress Pattern

After conducting the visual condition survey, the prevalent defects observed are cracking, potholes and raveling. The critical values among the defect were analyzed thoroughly in order to establish the current rating of the road surface. Weighted failure of each defect were calculated and the result are; cracking=2.098, pothole=9.306 and raveling=0.016. Having obtained the results, total weighted failure was also computed by summing the above results i.e. 11.474. The obtainable results were then compared with standard table 3.0 and approximate surface rating of the road system was established as 2.5

- iii. It is also recommended that the road need full depth reconstruction with extensive base repair using the rating score obtained.
