INTERNATIONAL JOURNAL  
OF ENGINEERING APPLIED SCIENCE  
AND TECHNOLOGY

# ADVANCED APPROACH IN SOLAR PV PLANT PROTECTION SYSTEM

V Venkatesh<sup>1</sup>, D Vamsi Krishna<sup>2</sup>, KV Kalyani<sup>3</sup>, Ashutosh Saxena<sup>4</sup>  
Centre for Mining, Environment, Plant Engineering and Operations (CME)  
National Council for Cement and Building Materials, Hyderabad, INDIA

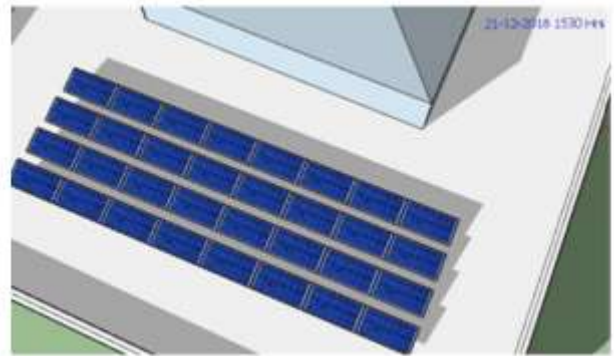
**Figure 1:** Shadow Analysis of rooftop

mounting solar PV panels. NCB-H has identified three buildings for installation of plant, among which administrative building is selected after performing shadow analysis. Shadow analysis is done to analyze the day light conditions at different time periods on a day at preferred location of the rooftop of NCB-H administrative building. Solar PV plant is designed in such a way that the modules are connected in strings to produce DC power output. Two strings are i.e. 16 No's of PV modules for each string making a total of 32 No of PV modules for two strings which are connected in parallel to the inverter. Inverter is provided with anti-islanding protection where inverter senses the power interruptions from the supply grid and shut itself to stop feeding power back to the grid. Protective devices for different DC and AC supplies are installed in inverter viz. DC reverse polarity protection, DC switch for MPPT, output AC over current protection, Output AC overvoltage protection, ground fault monitoring, grid monitoring and sensitive leakage current monitoring unit.

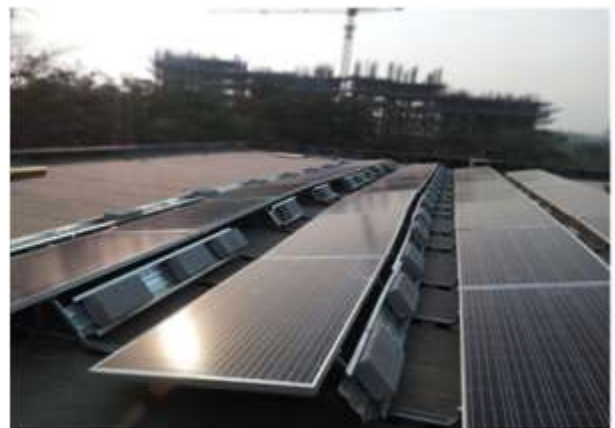
**Figure 2:** Solar PV Plant on rooftop of NCB-H

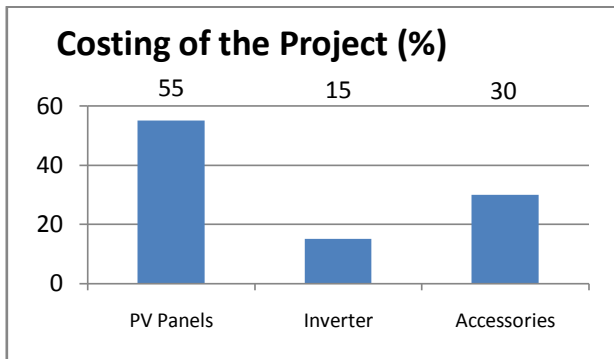
**Figure 3:** Costing of the solar (PV) plant

The percentage costing of components out of the total project cost is shown below.

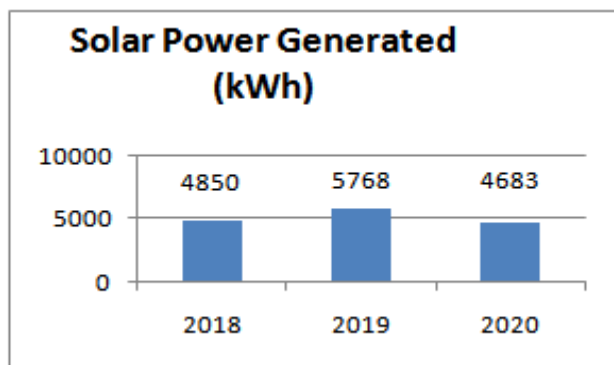
**Figure 4:** Solar PV plant generation trend

The energy generated till December 2020 is 15301 units. The savings realized from the generation of solar PV plant is around 1.4 Lakhs.

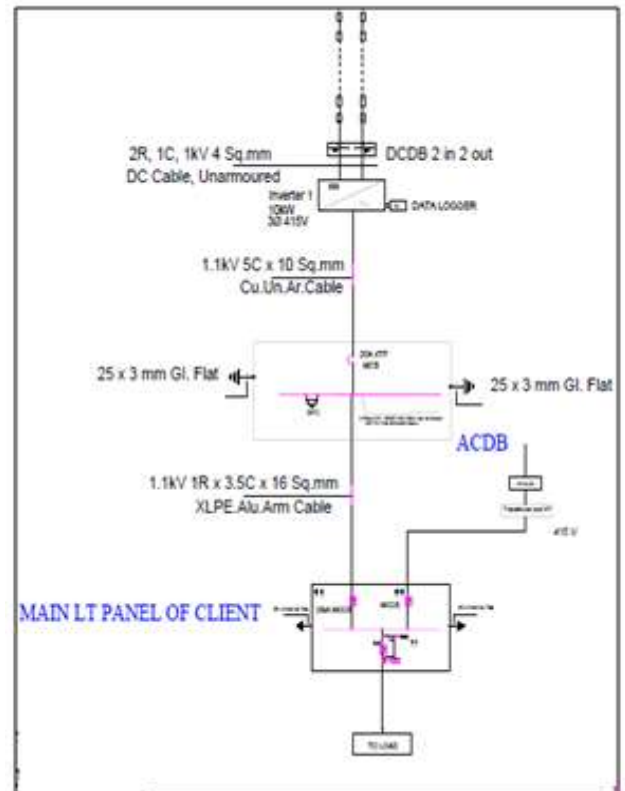
The Solar PV Plant comprises of PV Array, DC Distribution Board, Inverter and AC Distribution Board with a reference voltage from the existing panel. The solar power plant has various power electronics and other electrical components, there might be chance for power interruptions due to improper functioning of switch gear. The power flow from array to the existing electrical panel has been shown in the below single line diagram:

**Figure 5:** Single Line Diagram of Solar PV Plant

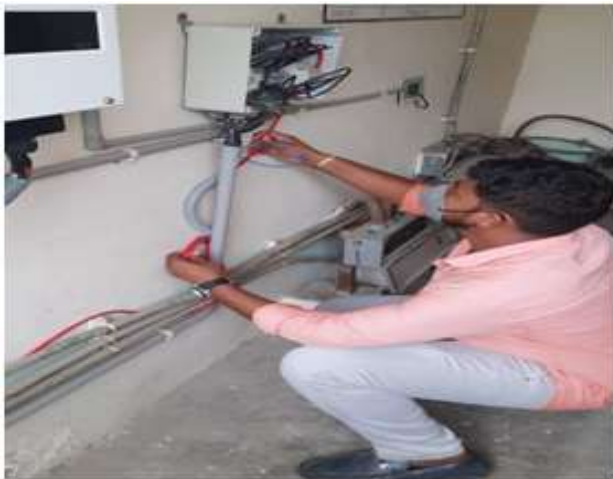
**3.2 Inverter faults:** It is observed that inverter is showing Error-117 on the display of inverter which indicates that there is a fault in the relay circuit in the inverter.

**Root cause analysis:** The healthiness of SPD in AC & DC Distribution Board, miniature circuit breaker of existing panel has been verified and found that AC Distribution board SPD burnt off. The other solar PV plant components like DC and AC cables have been thoroughly inspected and observed that there is no damage in the insulation. The SPD has been replaced with new SPD but inverter is showing the same fault code.

**Figure 6:** Technician providing dedicated DC Earthing

The inverter manual has been studied in detailed for additional technical information and manual is suggests to have separate earthing for AC and DC system. The earthing of the AC & DC system of solar PV plant has been studied in detail and found that earthing has been made common for AC & DC. The international standard (**IEC 60364 Part 7-712**) for Low voltage installations, requirements for special installations or locations – solar photovoltaic (PV) power supply systems also suggesting to have separate earthing system for AC and DC system in Solar PV plant. Based on the above technical deliberations and discussions with inverter manufacturer, earthing of AC and DC has been separated. The inverter became functional after replacement of relay component which might got damaged due to infusion of fault current because of combined AC & DC earthing.

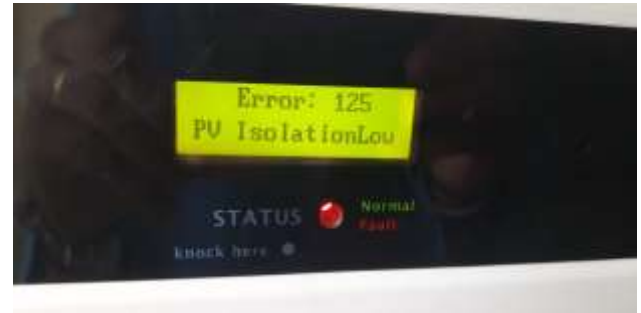
**1.3 PV Isolation low:** It is observed that inverter is showing Error-125 on the display of inverter which indicates that the inverter has detected a problem with the insulation of the system.

**Root cause analysis:** In humid weather conditions, it is often noticed that the occurrence of Error-125. The moisture ingress in the cable causes the DC current of the solar panel to leak to the earth on the array frame. The inverter senses the fault and shuts the system for its safety. Once the moisture is evaporated with rise in temperature from the sun the error extinguishes itself and the system starts to work again.

**Figure 7:** Error: 125 display on the inverter screen

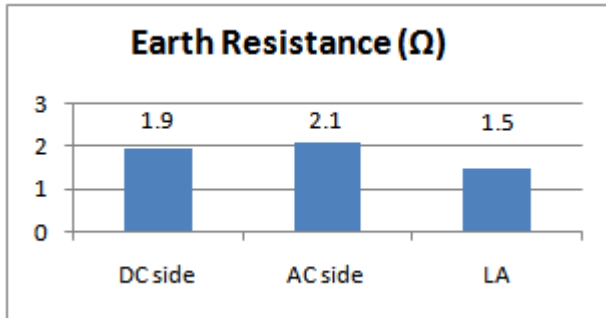
Regular checking of earth pits is the best preventive maintenance activity performed in any electrical system. The earth resistance is measured with the help of Digital Earth resistance tester for DC, AC and LA at regular intervals. The measured Earth pit resistance values of DC, AC and LA are shown in graph below:

**Figure 8:**Earth pit resistance values of DC, AC and LA
