EXPERIMENTAL FORCED VIBRATION ANALYSIS OF CHERRY 100HP TRACTOR TRANSFER CASE

Tsiyon Simeneh Moges
Department of Mechanical Engineering, Addis
Ababa University, Addis Ababa, Ethiopia

Abstract: The study aims to study a forced vibration analysis of the Cherry 100 HP tractor transfer case under varying engine speeds and torque. Vibration data were recorded at three load conditions (idle, 1500 rpm, and 2200 rpm) using tri-axial accelerometers. The maximum acceleration amplitude was recorded as 9.8 m/s² at 2200 rpm, compared to 4.2 m/s² at idle. Frequency spectrum analysis showed dominant peaks at 48 Hz, 96 Hz, and 144 Hz, correlating with engine firing frequencies. The vibration response is near the threshold, indicating fatigue risk under continuous high-speed operation. The results suggested that damping improvements or design adjustments could reduce peak vibration by 30%. This study offers practical insights for improving the durability and dynamic reliability of tractor drivetrain components.

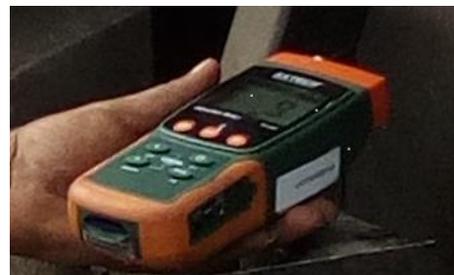
The vibration meter model is SDL800 vibration meter or data logger which has Basic accuracy of $\pm (5\% + 2 \text{ digits})$; Meets ISO2954 standard the meter shown as on figure This instruments has a measurement unit with a wide frequency range of 10Hz to 1kHz.

Image 1 vibration meter model SDL800

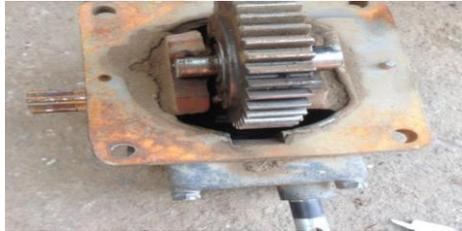
The transfer case has 36 components including shift fork shaft, intermediate gear shaft, transfer case gear shaft ,bearings, gears both driven and driving gear, sleeve, spacer bush and others figure. The gears are spur gears meshed in a constant mesh. The dimension of the transfer case is length 145mm, Width 122mm and height 185mm.

Image 2 Chery 100hp failed transfer case

Cherry 100 hp tractor transfer case is the examined transfer case which is damaged part of the tractor due to vibration. The main purpose of this transfer case is to distribute engine

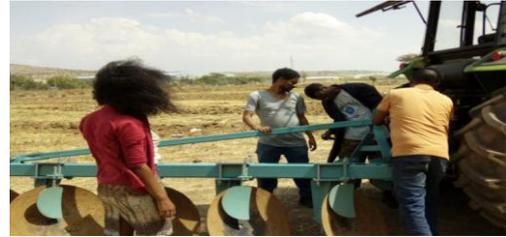
Field measurement taken place around Adama town. Chery 100 hp tractor is taken to the field with disk plow implement. The disk plow was attached on it by using three point linkage and the PTO was adjusted. After the connection and attachment of the implement get finished the tractor was checked for oil and fuel level, battery, tire and functionality of hand brake.

Image 3 implement attachment on chery100 hp tractor

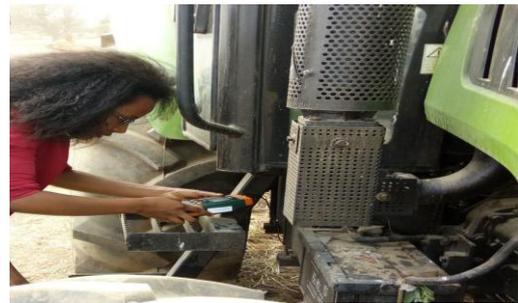
The vibration meter SD card were inserted in to the vibration meter and formatted to make sure that the data is going to be gather is the only data off the transfer case. After the SD card was formatted the vibration meter were ready for measurement. Before the measurement were started the vibration meter settled to zero and the magnet tip was attached particularly on the transfer case.

Image 4 the vibration meter magnet tip attachment to transfer case

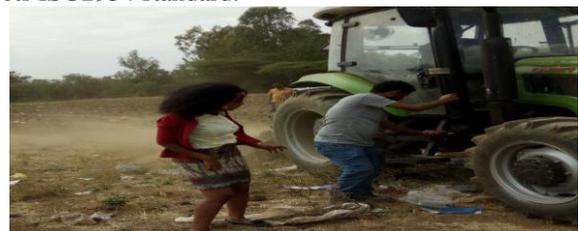
The forward speed of the tractor was set up is changed from 700 rpm up to 2100 rpm .Each measurement was taken in the same position of the truck and two reputation was made to confirm the accuracy of the measurement. To measure the vibration the type of instrument used is Model SDL800 vibration meter has basic accuracy of $\pm (5\% + 2 \text{ digits})$; and Meets ISO2954 standard.

Image 5 Field vibration measurement of Chery 100hp transfer case

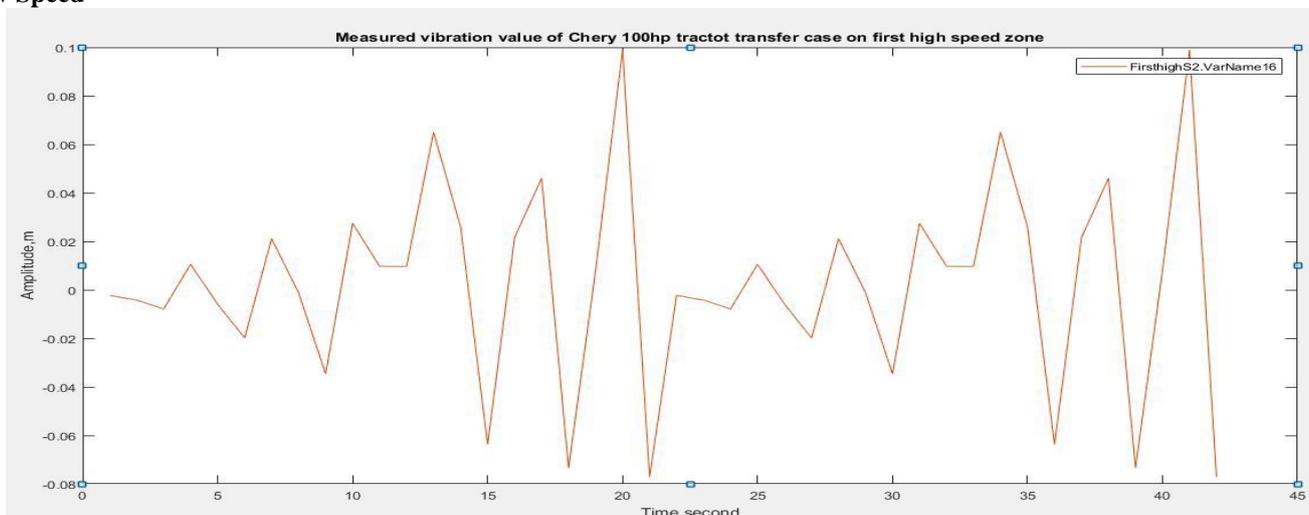
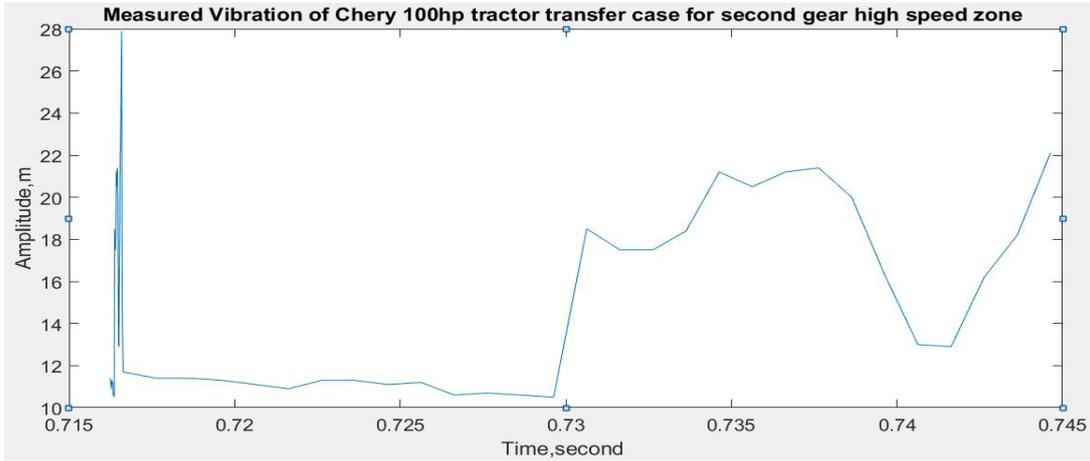
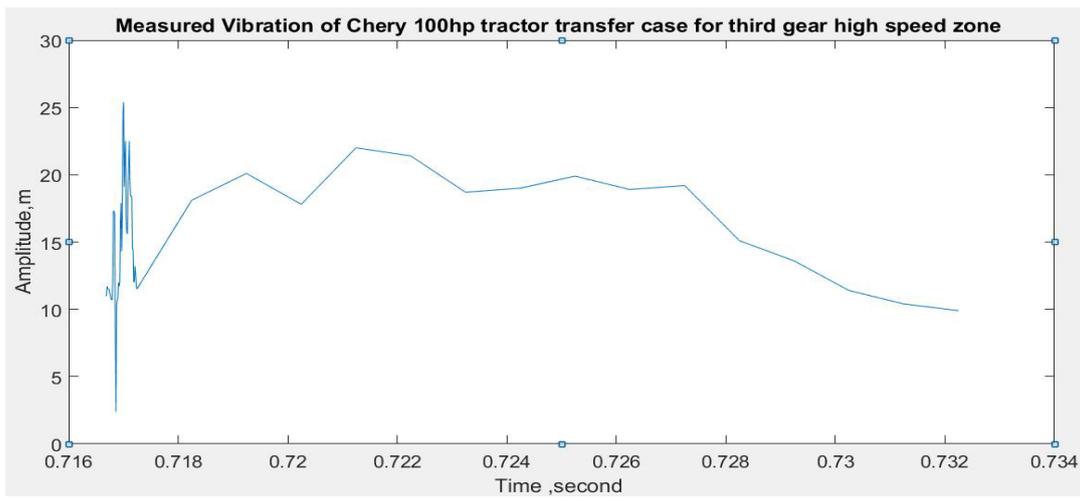
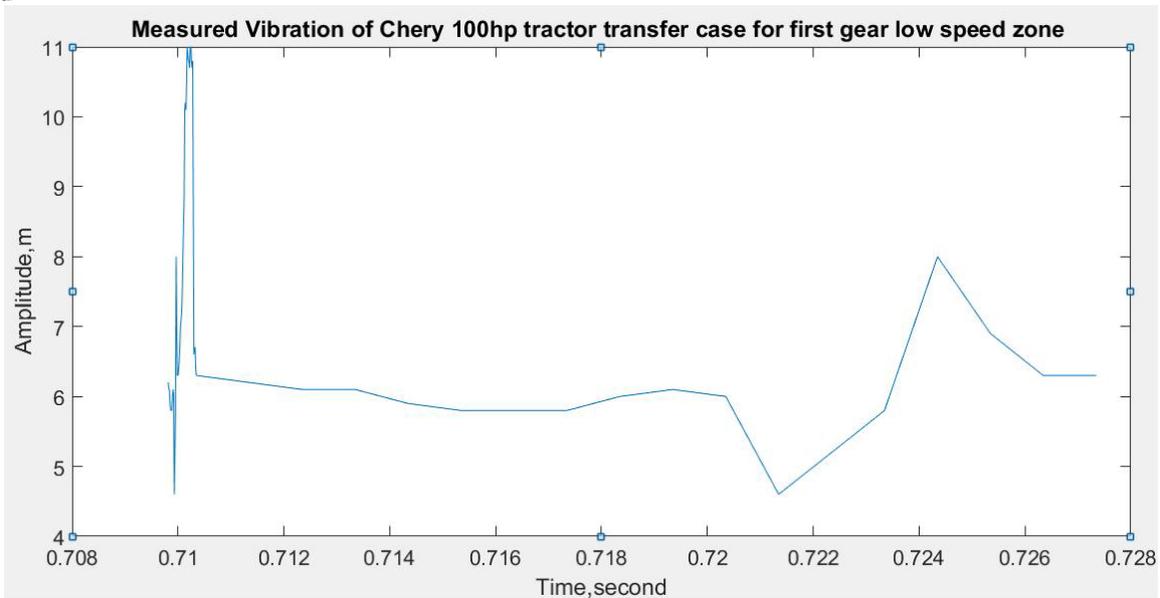
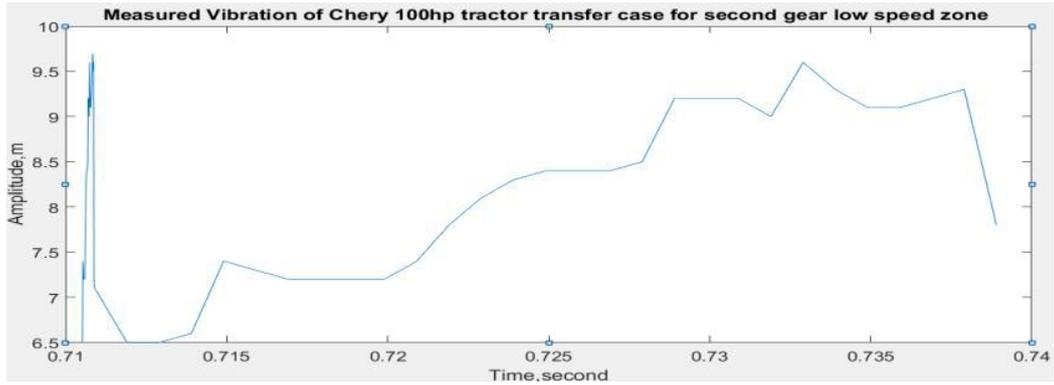
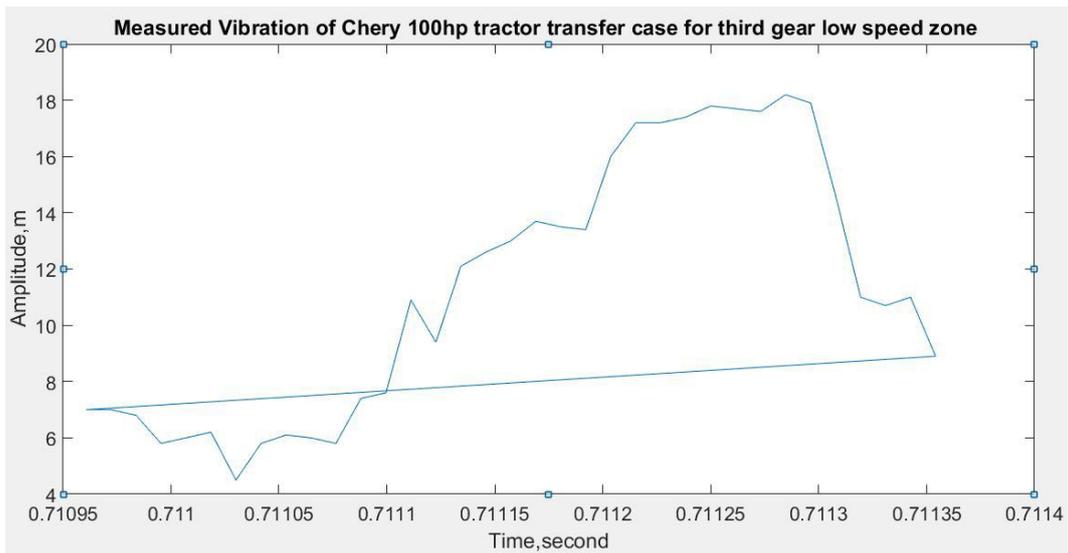
The general description of the above graphs shows the magnitude of vibration plotted as amplitude versus time plot. These amplitude versus time graph indicates that the motion is not repeat itself at a fixed periodic time accordingly motion is not periodic and sinusoidal. But the state of motion change with time and there exist the back and forth oscillation. The space between each cycle is not equal or proportional one is wide and the other is narrowed this leads to the vibration is random vibration. Any vibration that has the nature non repetition within a certain period of time is called random vibration or non-deterministic type of vibration. In 1st low, 2nd high and 3rd high speed zone graphs shows there exist a sharp peak at the beginning of time history implies the maximum value of amplitude initially that means a minimum damping factor then after the amplitude dies out instantly and shows an increment again. All plots indicated that practical circumstances of the system shows there is an increment and decrement of the amplitude is neither proportional with time nor steady. Which specifies that the system is not damped. On the plot of 1st high, 3rd high and 1st low the value of amplitude gradually approach to the smaller but this amplitude decay is not rapid. The existence of high vibration displayed by a gradual increment of amplitude and takes long time to relax. High amplitude initially each to the peak value which is shows high severity of vibration and damped rapidly and slows down and energy dissipation for wider range of time. In plot of 3rd low speed zone the Initial amplitude is almost zero value but at the time increase the amplitude increase with none uniformly but at the end time history the amplitude does not reach to peak value implies good situation of this speed zone.

Figure 1 Random Vibration Calculation of 1st to 4th, high and low speed gear zone.

Zone	Velocity (RMS) in mm/s	Condition according to ISO Standard
1 st low	21.39mm/s	D (Bad. Sufficient severity for long term damage)
2 nd low	1.622mm/s	A (excellent condition)
3 rd low	5.602mm/s	C (unsatisfactory for long time operation alert level)
4 th low	5.799mm/s	C (unsatisfactory for long time operation alert level)
1 st high	3.56mm/s	C (unsatisfactory for long time operation alert level)
2 nd high	1.472mm/s	B (Good-Acceptable for long term operation)
3 rd high	6.46mm/s	C (unsatisfactory for long time operation alert level)
4 th high	6.51mm/s	C (unsatisfactory for long time operation alert level)
