# SEISMIC CONDITION ASSESSMENT OF TEMPLE A CASE STUDY ON SHIVA-PARBATI TEMPLE

Dinesh Raj Bhattra

**Abstract—** Shiva Parvati temple is an uncommon shrine built on a four-step brick platform. It stands out particularly due to its three golden pinnacles. It was Bahadur Shah Idea to construct a hybrid temple that incorporated Newar and Rajput style on top of the pavilion built by King Laxmi Narasimha Malla who ruled in the seventeenth century. The temple has been renovated in 1998AD. The golden pinnacle of this temple is quite artistic and one of the best in the Durbar Square. It consists of three tapering spires alternating with four floral stalks on a small platform. It is unique because it departs from the traditional Newar appearance and adopts the Rajput/Mughal style. Shiva-Parvati Temple which is adorned with images of Shiva and his consort Parvati. With its “Shiva-Parvati Temple” historical importance as Monument underlying the UNESCO World Heritage Sites and One which is affected by the Gorkha Earthquake (2015). The main objective of the study is to carry out seismic condition assessment of the temple based on detail damage assessment. A set of Architectural and Structural D

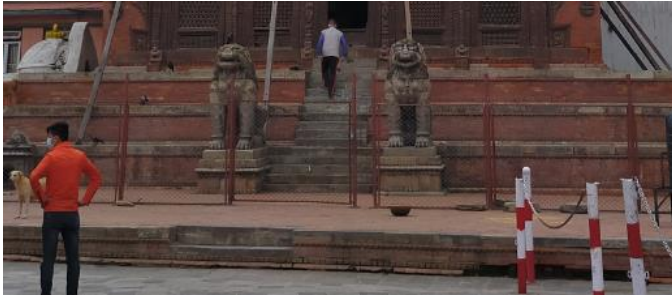
The foundation is not exposed in the Shiva-Parvati Temple. The foundation may have a stepped footing according to the literature review and study of the similar temples. But temple has a Wide Plinth as shown in figure 2.

Fig. 2. Section of footing

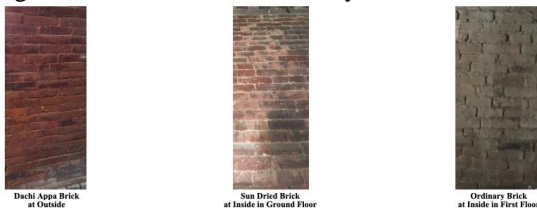
It was observed at site that, the external brick wall is exposed of Single Layer of Dachipa Bricks (having a thickness of 4-5" thick] on all the elevation sides, ordinary brick masonry in the middle portion and Sundried brick masonry work to the inside, which can be depicted in figure 3 representing from left to right. However, the middle portion of the wall is not visible; it might be filled with brick masonry works in different bonds.

Fig. 3. Section of wall
