ANTI-EROSION AND RIVER TRAINING WORKS ALONG THE BANKS OF RANGANADI RIVER, ASSAM

Abstract— Flood and erosion are the two major problems of lower plain reach of Ranganadi River and hence become a matter of concern due to their devastating impact on life and property. With gradual rise in river bed over decades, discharge at the d/s reaches increases in monsoon period suddenly leading to flood-lift within a very short period and threatens both left and right bank embankment system of Ranganadi River. Every year flood-lift decreases the free board and causes overtopping. Now, for the safety, embankment system is to be raised and strengthened to overcome anticipated flood lift. This paper describes the case study of river training works at the most vulnerable reaches with launching of geotextile bags as the apron and geotextile mattress at the slope of embankment etc rather than the conventional type of boulder works since the boulder has become scarce. The project Ranganadi is located in the North Lakhimpur district of Assam. The laboratory investigations undertaken for geotextile materials and gabions for the Ranganadi project are presented in this paper along with advantages of usin

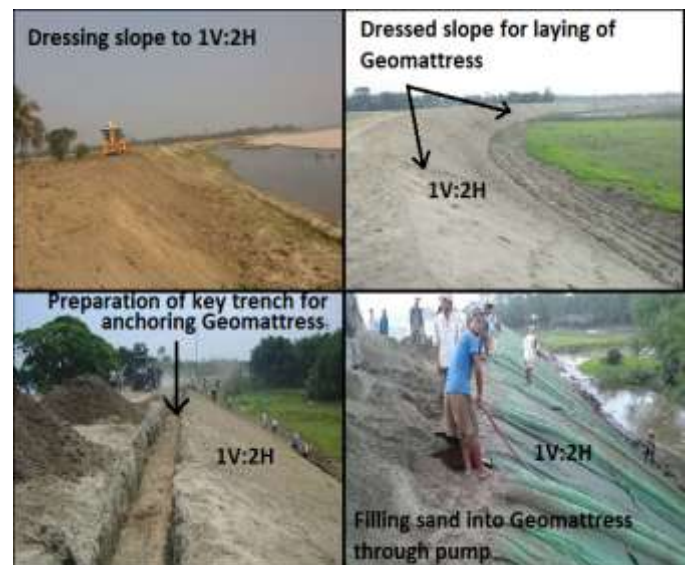
Fig. 5. Installation of Geotextile mattress at various stages

Bank revetment and launching of apron is being carried out for left and right bank embankment of Ranganadi River at various vulnerable reaches for a total length of 7200 m where the river bank is dressed to the inclination of 1V: 2H and over this a layer of geotextile tubular mattress of 0.3 m fill height is laid and anchored at the top and toe of bank slope by bending the mat into key trench of size 1.0 m x 0.75 m. Geotextile mattress is a double layered composite geotextile fabricated to form a three dimensional mattress after filling sand through pump at design slope of affected reach, the upper layer of the mattress is made from polypropylene woven geotextile needle-punched with a mixture of Ultraviolet (UV) stabilized green fibers and cut tape yarns and the lower layer of the mattress is also a UV stabilized polypropylene woven fabric. Total quantity of geo-mattresses under use is 1061939 m². Figure 5 shows installation of geotextile mattress at various stages.

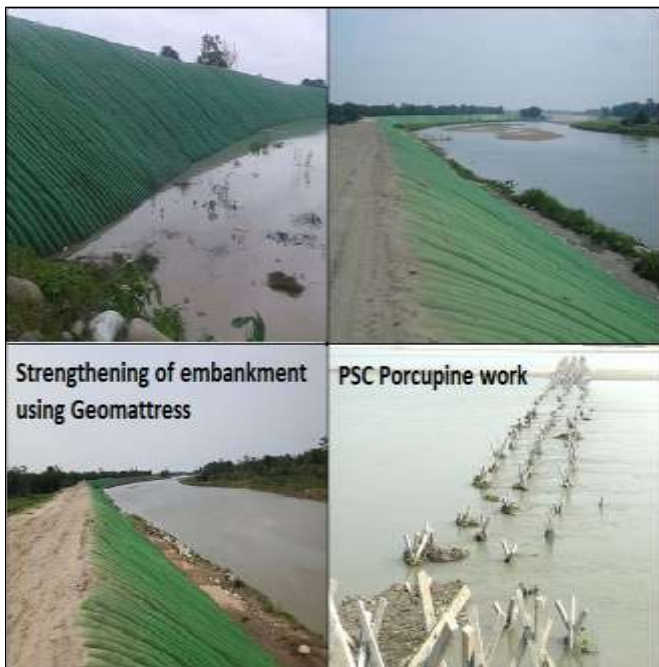
Fig. 7. Implementation of geotextile mattress and porcupine works

The paper presents the problems and the remedial works along the vulnerable reaches of River Ranganadi. The problem of flood and erosion in Assam is of high magnitude and to effectively deal with these issues, permanent solution will be essential in the near future. Such application replaces all other conventional methods (e.g. boulders, RCC etc.) for immediate protection where flood is a regular phenomenon and construction is to be completed in a limited time period. The use of geotextiles materials permits to carry out the protection works at a faster rate. The use of the mechanically twisted zinc coated wire mesh gabion box ensured the stability of the geotextile bags and provide confinement in toe-key. Figure 7 shows implementation of geotextile mattress and porcupine works.
