ASSESSMENT OF GROUNDWATER QUALITY WITH SPECIAL EMPHASIS ON IRRIGATION AND DOMESTIC SUITABILITY IN SEMPATTU AND GUNDUR AREA, TIRUCHIRAPALLI DISTRICT, TAMILNADU, SOUTH INDIA

R. Soundar Rajan,
CSIR-National Geophysical Research
Institute,
Hyderabad - 500 007, India

Abstract : The hydro-chemical study of groundwater samples was carried out from the Sembattu and Gudur area of Tiruchirapalli District, Tamil Nadu (latitudes 10°43'14.54"N – 10°45'3.52"N and longitudes 78°42'31.35"E - 78°43'44.815"E) with an objective of understanding the suitability of local groundwater quality for irrigation and domestic purposes. For this study groundwater samples were collected from 20 (twenty) locations during the time spanning over 2018 and 2019. Groundwater samples were analyzed for their physical and chemical properties using standard laboratory methods. From the analyzed data, some parameters like SAR, TDS, etc., have been calculated for each water sample to identify the irrigational suitability. Based on TDS range, majority of the samples from the study area are found to be Fresh water; and few are found to be slightly saline. The electrical conductivity and the pH values in most of the samples

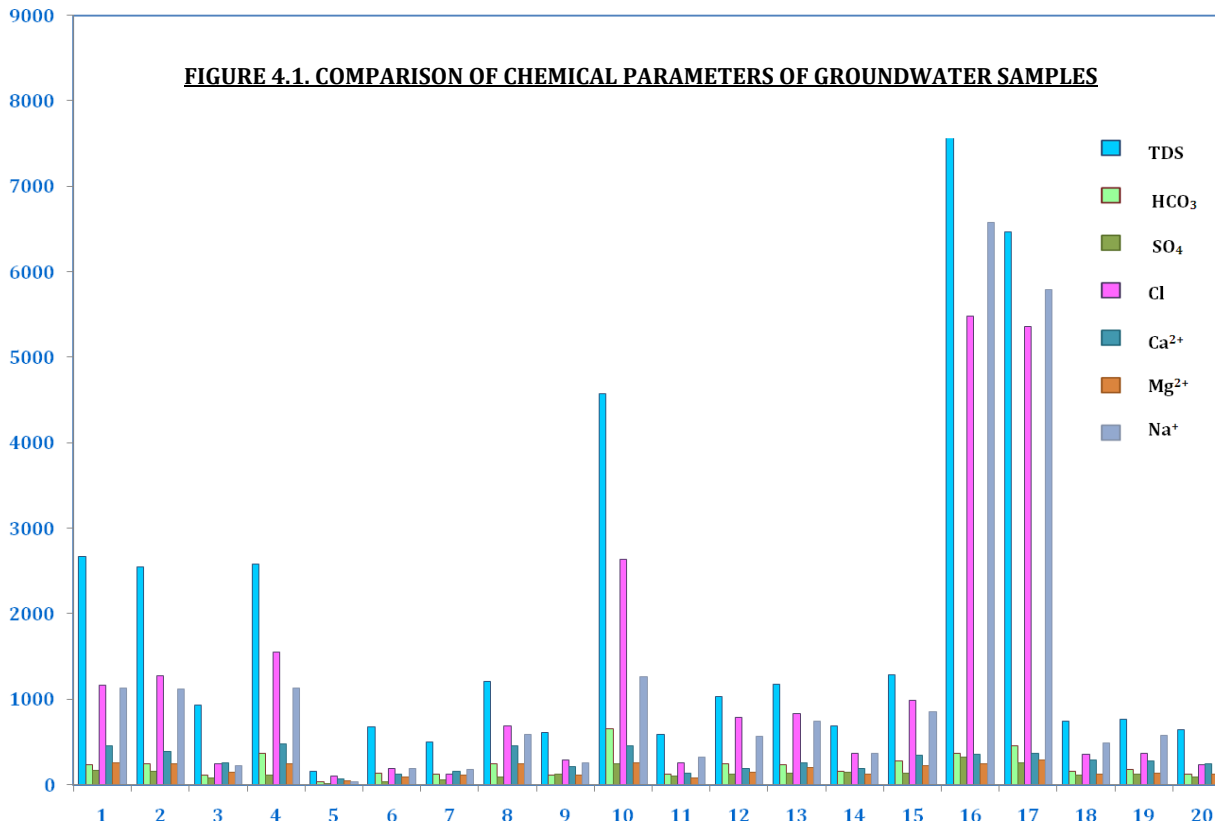
Water samples have been collected from 20 tube wells and analyzed. The results are tabulated in ppm are depicted in **Table 4.1.** and the graphical representation of the same is also given as **Figure 4.1.**

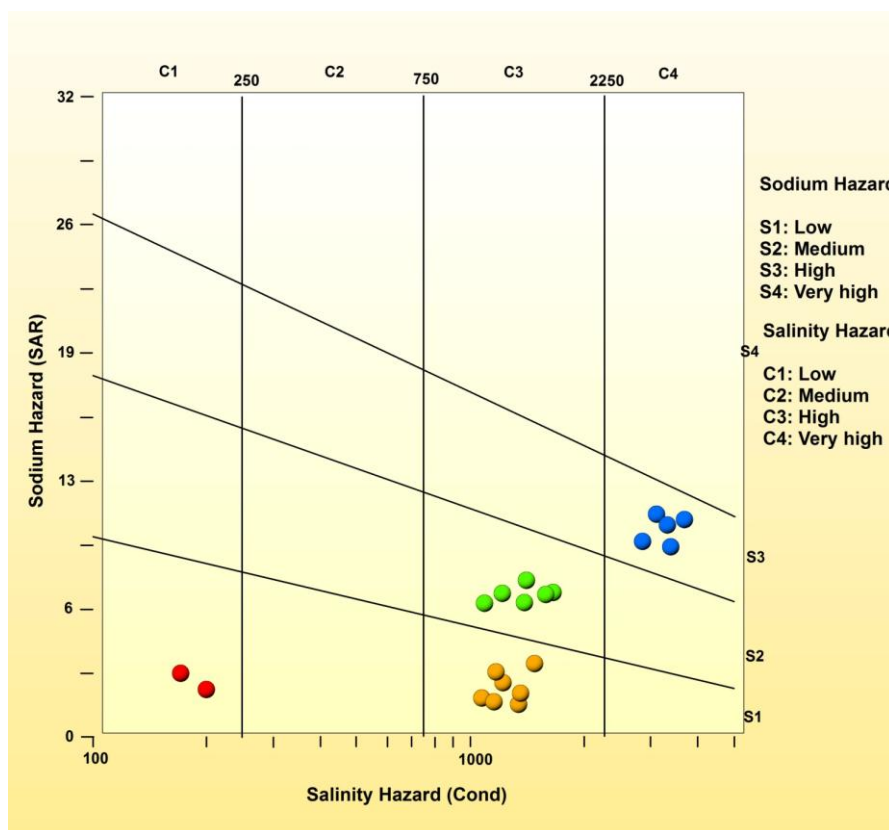
4.3. USSL PLOT

The U.S. Regional Salinity Laboratory has constructed a diagram for the classification of irrigation waters (Wilcox 1955) describing sixteen

classes with reference to Sodium Adsorption Ratio (SAR) as an index for sodium hazard and electrical conductivity (EC) as an index for salinity hazard (**Figure 4.3.**).

The USSL diagram (USSL 1954) highlights that seven samples fall under the field of C3S1, which indicates water having high salinity and low sodium alkali hazard. Whereas, 6 samples fall under C3S2 category indicating high salinity hazard and medium sodium hazard and 5 samples are having very high salinity and high alkali hazard (C4S3), while remaining two samples fall under the C1S1 field. Medium-salinity water (C2) can be used if a moderate amount of leaching occurs. Plants with moderate salt tolerance can be grown in most instances without special practices of salinity control. High salinity water (C3) with low sodium water (S1) is satisfactory for plants having moderate salt tolerance, on soils of moderate permeability with leaching. Very high salinity water (C4) and high sodium water (S3) cannot be used for irrigation purpose under ordinary conditions but may be used occasionally, under unavoidable circumstances.

- 11) The USSL diagram (USSL 1954) reveals that 7 samples fall under the field of C3S1, which indicates water having high salinity and low sodium alkali hazard Whereas, 6 samples fall under C3S2 category indicating high salinity hazard and medium sodium hazard and 5 samples are having very high salinity and high alkali hazard (C4S3), while remaining two samples fall under the C1S1 field. Medium-salinity water (C2) can be used if a moderate amount of leaching occurs. Plants with moderate salt tolerance can be grown in most instances without special practices of salinity control. High salinity water (C3) with low sodium water (S1) is satisfactory for plants having moderate salt tolerance, on soils of moderate permeability with leaching. Very high salinity water (C4) and high sodium water (S3) cannot be used for irrigation purpose under ordinary conditions but may be used occasionally, under unavoidable circumstances.
