DETERMINING THE RECOVERY RATE OF DICHINAMA MARBLE (LIDGE MARIAM) QUARRY SITE AT NORTHWESTERN ZONE, TIGRAI, ETHIOPIA

Yemane Kide Hailemariam
Department of Mining Engineering
Indian Institute of Technology (ISM) Dhanbad
Dhanbad, Jharkhand, India

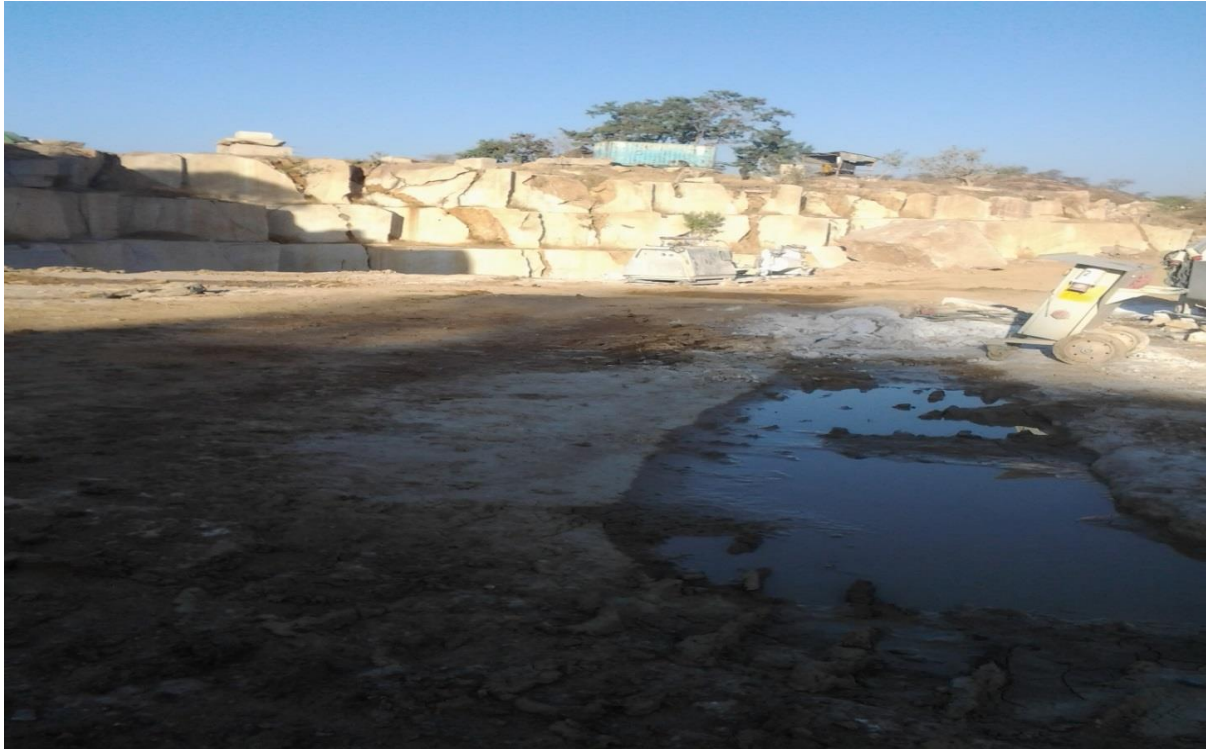
Fig. 2. Dichinama Marble (Lidge Mariam) Quarry Site

In the study area of Dichinama Quarry Marble (Lidge Mariam) site the first step in quarry mining which includes the removal of unwanted materials like plants, soil, weathered rocks, and other materials cleared from the deposit (mineralized area) using the loader or using diamond wire cutting machines it depends on if the material is soft such as soil and plants loader is preferable unless diamond wire cutting machines to uncover the Marble which is economically important.

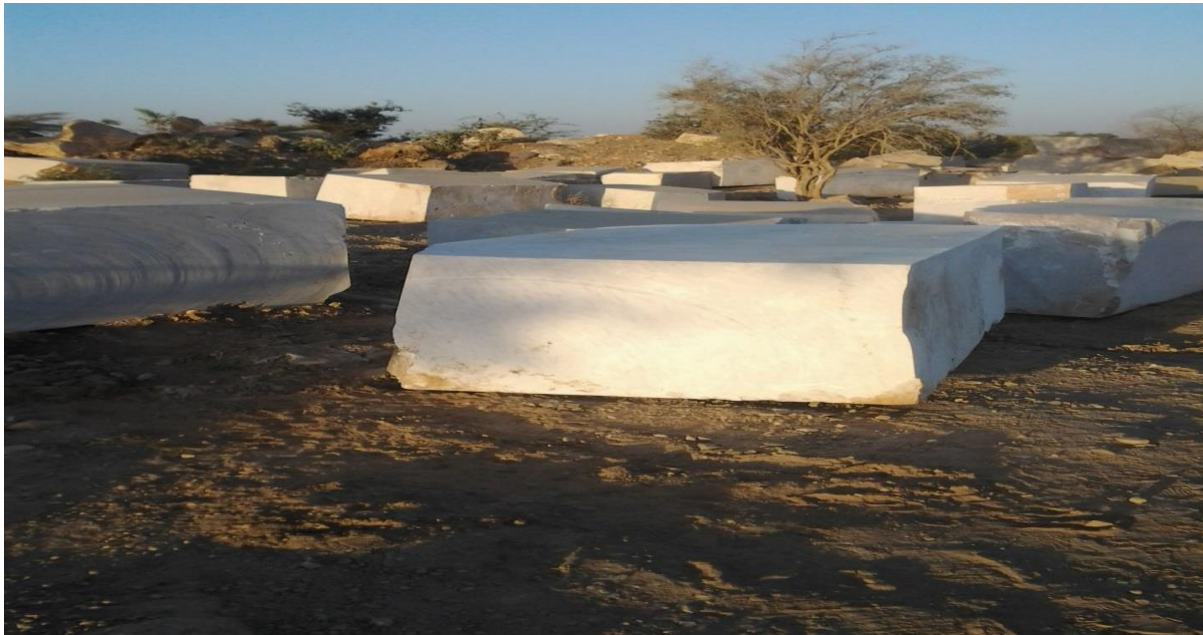
Fig. 3. Stock Yard of Dichinama Marble (Lidge Mariam) Quarry Site

Finishing the squaring process, the loader operator hauls (brings) the standard squared block from the working face of the quarry bench to the stockyard where by the squared block is kept. In the stockyard the quality control personal gives grade and dimensions to the squared blocks according to their geological nature shown in the (Table 5) below. The grading system of Dichinama Marble (Lidge Mariam) Quarry Site depends on the dimension of the Squared block and the presence of the geological discontinuities or structures present in it the grade is given as; Grade A, Grade B, Grade C, and Rejected block tabulated below as follows: Table 5 Grading system of Dichinama Marble (Lidge Mariam) Quarry Site of Squared Blocks.

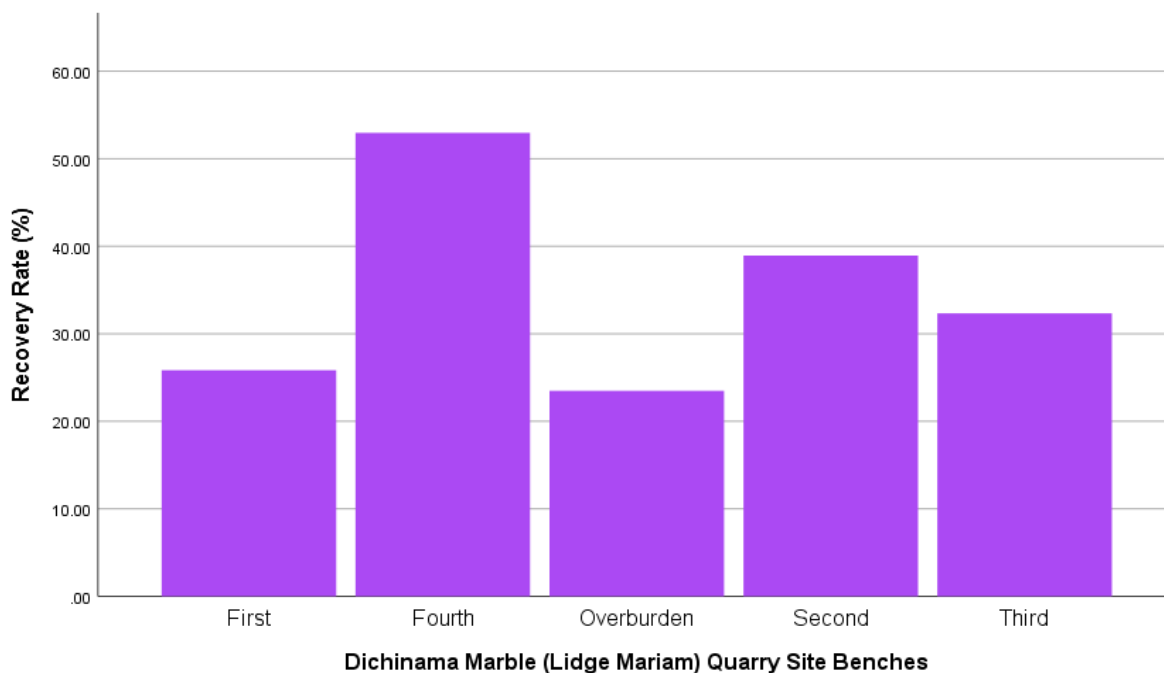
Fig. 4. Recovery Rate of Dichinama Marble Quarry Site from July, 2008 upto June, 2011

Dichinama Marble (Lidge Mariam) Quarry site have different recovery rate in the four benches and overburden cuttings in the first bench 25.84%, second bench 38.93%, third bench 31.97%, fourth bench 52.96%, and from the overburden 23.49%. So, from this there is a great difference among first bench, fourth bench, and overburden. The main reason for this is the geological discontinuities and found in the marble quarry. According Ashmole and Motloun, (2008) It is obvious that Marble is affected by geological structures same is true in the marble quarry of Dichinama (Quarry site) especially the third bench is highly affected by cavity.
