INVESTIGATING THE CAUSES OF FREQUENT FAILURES IN FLEXIBLE PAVEMENTS ON HIGHWAYS IN BANGLADESH: A CASE STUDY OF THE DHAKA–SYLHET CORRIDOR

Subrata Chowdhury
Associate Professor,
Department of Civil Engineering
Stamford University Bangladesh
Dhaka, Bangladesh

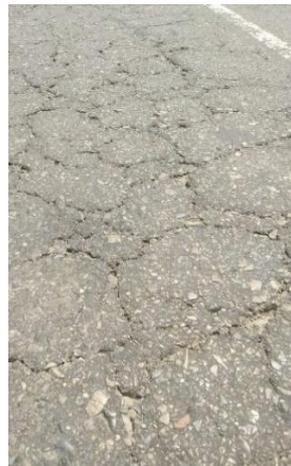
- **Alligator cracking (8 sites):** These cracks typically develop from asphalt fatigue caused by repeated axle loading. Their occurrence indicates insufficient pavement thickness or degradation of the asphalt binder and aggregates, pointing to fatigue-related structural inadequacy.

Fig. 2. Photographs Presenting: (a) Alligator Cracking (Location: Ruposhi); (b) Slippage Cracking (Location: Madhubdi); (c) Transverse Cracking (Location: Ruporshi); (d) Pathholes (Location: Madhubdi); (e) Raveling (Location: Bhulta); (f) Bleeding (Location: Madhubdi); (g) Corrugation and Shoving (Location: Bhulta); & (h) Depression (Location: Ruposhi).

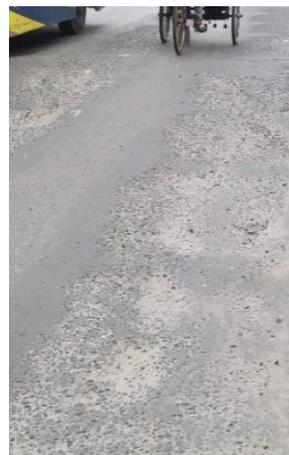
(b)

- **Slippage cracking (7 sites):** Characterized by crescent-shaped cracks, these are generally associated with poor bonding between successive pavement layers. Such failures reflect deficiencies in construction quality control, particularly inadequate tack coat application.

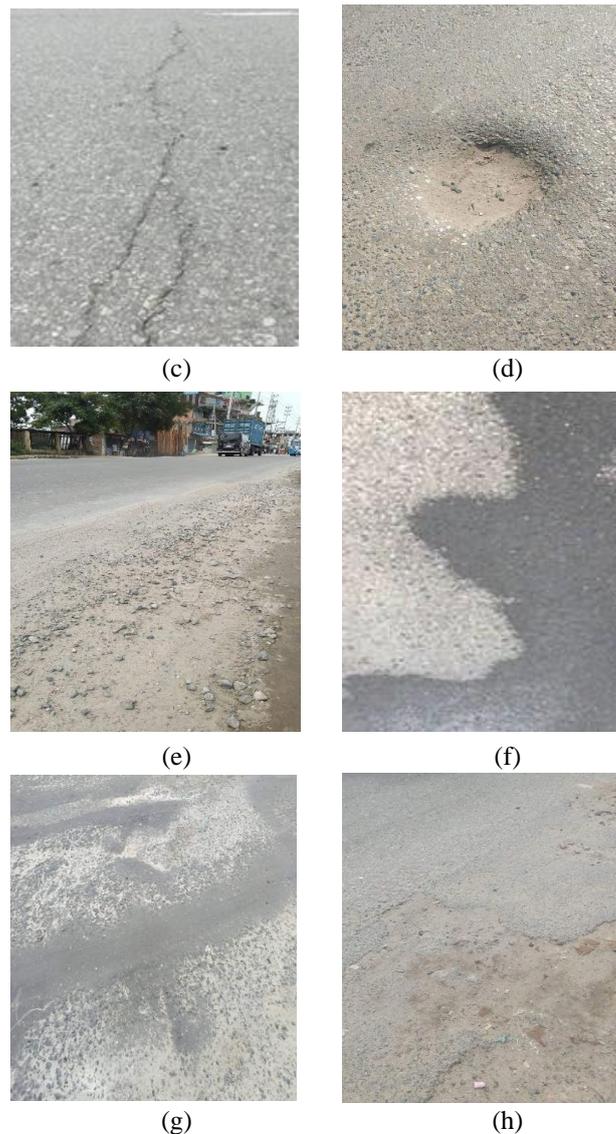
- **Transverse cracking (10 sites):** These cracks are primarily linked to temperature variations and thermal stresses. Their presence indicates insufficient flexibility of the asphalt mixture or inadequate accommodation of thermal expansion and contraction.

- **Potholes (7 sites):** These originated from untreated cracks that allowed water infiltration, which progressively weakened the underlying layers. The process was exacerbated by ineffective drainage and delayed maintenance responses.

- **Raveling (10 locations):** Raveling, characterized by the gradual detachment of aggregate particles, occurs due to binder hardening and poor bonding between asphalt and aggregates. This progressive deterioration eventually causes surface disintegration and exposes the underlying base layer.
- **Bleeding (12 locations):** Bleeding results from excessive binder content combined with inadequate surface drainage, leading to binder migration upward. This forms a shiny, sticky film on the pavement surface, which significantly decreases skid resistance.
- **Corrugation and shoving (19 locations):** The most prevalent distress type, corrugation and shoving, arises from unstable asphalt layers subjected to shear deformation under repeated traffic loads. This not only compromises ride quality but also highlights severe deficiencies in mix stability.

- **Depressions (6 sites):** These localized settlements were caused by weak or saturated subgrade soils, often aggravated by water accumulation and inadequate compaction during construction.
